Manhole Inspection Summary

Manhole # S67K__015MH

Insp Date: **3/1/08 1:05 PM**

Location Address: **912 Dundalk Ave.**

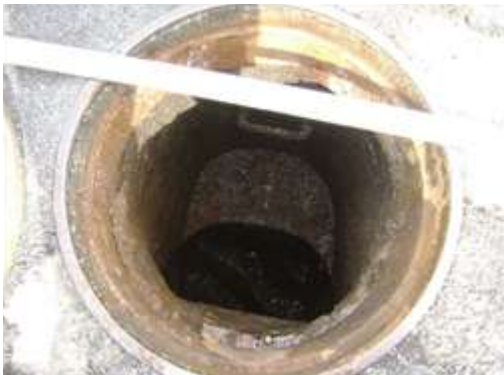
Defect 1

Offset: **1** (in.)

Offset frame defect

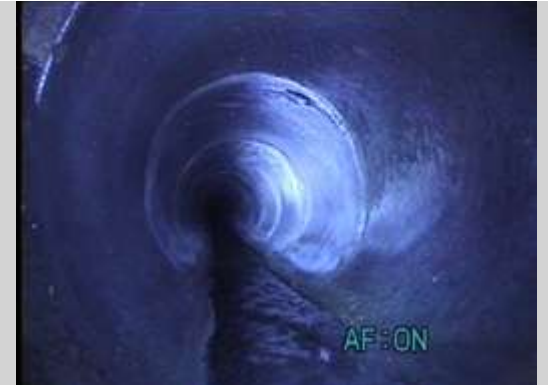
12 O'Clock Outflow

18 in. Circular Gravity Sewer
Pipe Out @ 12 O'Clock

Pipe Height: **18** (in.) Rod and Bar (Angled)
Pipe Material: **Clay** ☐ Pipe Lined
Invert Depth: **15.50** (ft.) Flow Characteristics: **Fast**
Deposits: ☒ None ☐ Mud ☐ Sludge ☐ Debris ☐ Grease
Silt Depth: (in.) Deposits Extent:
Infiltration: **None** Pipe Seal Cond: **Sound**

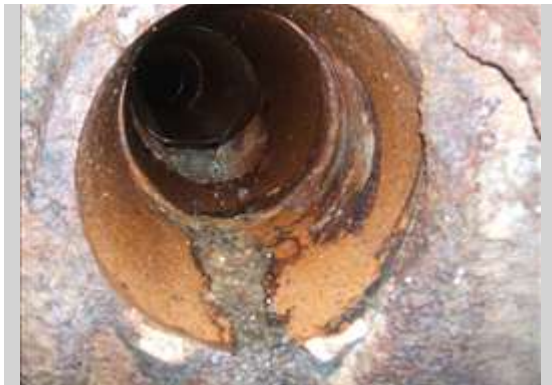
6 O'Clock Inflow

10 in. Circular Gravity Sewer
Pipe In @ 6 O'Clock

Pipe Height: **13.2** (in.) Rod Only (Angled)
Pipe Material: **Clay** ☐ Pipe Lined
Invert Depth: **13.40** (ft.) Flow Characteristics: **Fast**
Deposits: ☒ None ☐ Mud ☐ Sludge ☐ Debris ☐ Grease
Silt Depth: (in.) Deposits Extent:
Infiltration: **None** Pipe Seal Cond: **Sound**

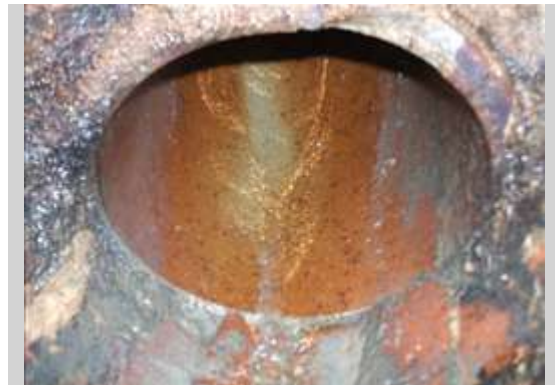
Drop In @ 6 O'Clock

Drop: **Inside** Rod Only
Angled: Reading: **14.20** (ft.)
Inv Depth: **14.20** (ft.)
Drop Condition: **Open**

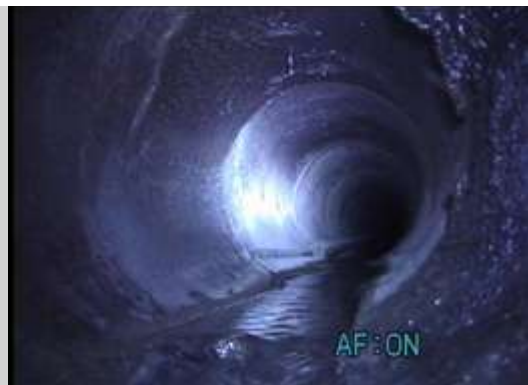
8 O'Clock Inflow

18 in. Circular Gravity Sewer
Pipe In @ 8 O'Clock

Pipe Height: **18** (in.) Rod and Bar (Angled)

Invert Depth: **15.33** (ft.) Flow Characteristics: **Fast**

Infiltration: **None** Pipe Seal Cond: **Sound**
